PP6 Bavarian Environment Agency - WP 5 - Monitoring stations

External Expert: Catholic University of Eichstaett-Ingolstadt - Chair of Physical Geography

Monitoring Station II – Arzbach/Isar (Arzbachmündung)

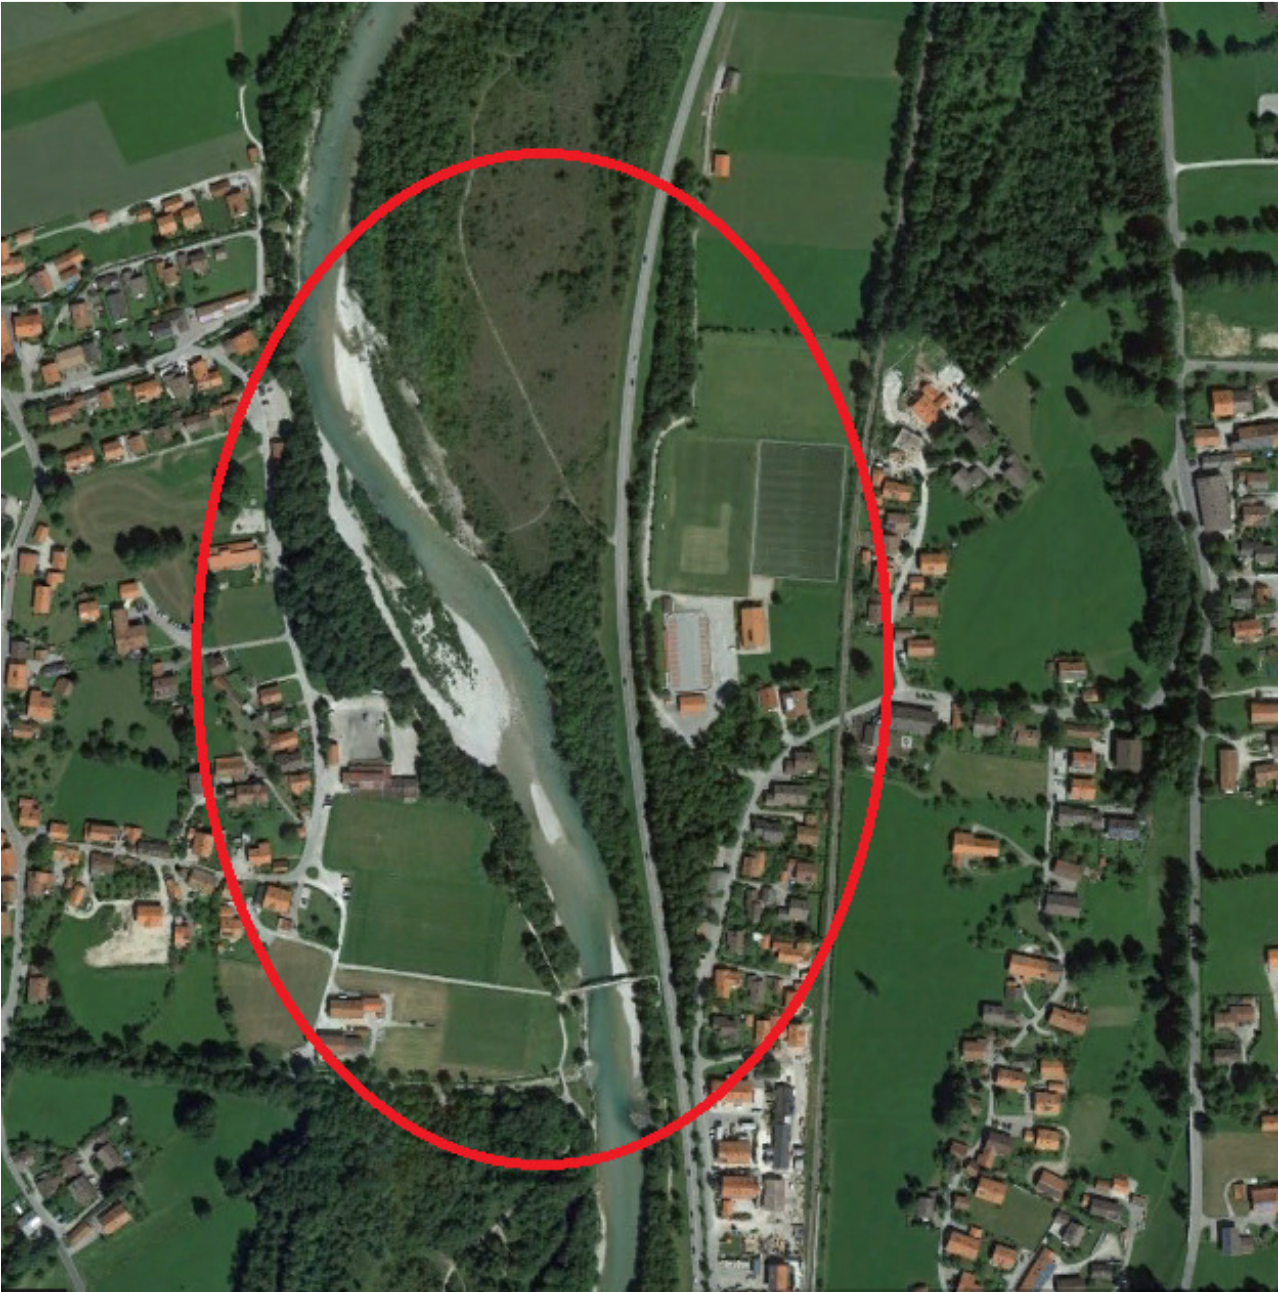
Figure 1: Overview "Arzbachmündung" and area of investigation (map based on Google Earth)

The "Arzbachmündung" site is located at the mouth of the Arzbach torrent into the Isar. It is located next to Arzbach. Coordinates of the embouchure are: N 47°42'32.50" – E 11°33'41.21"

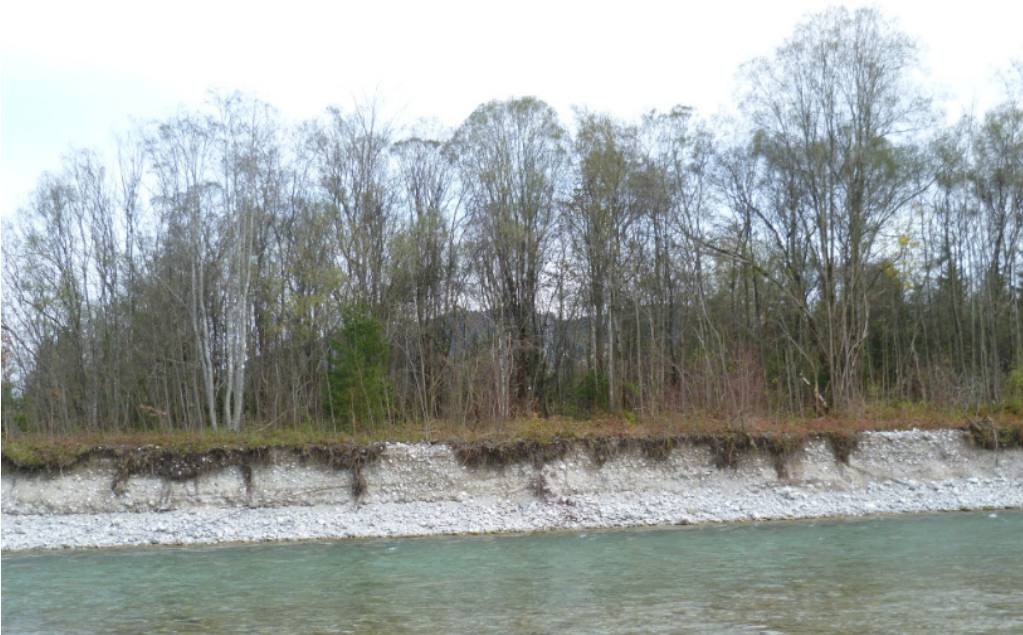
Figure 2: Erosion at the bank of the Isar near Arzbach mouth

The investigations should focus on the delivery of bed load material, the gravel bank development, changes at the gravel banks of the river Isar (Figure 2) and the influence of different discharge situations on river morphology.

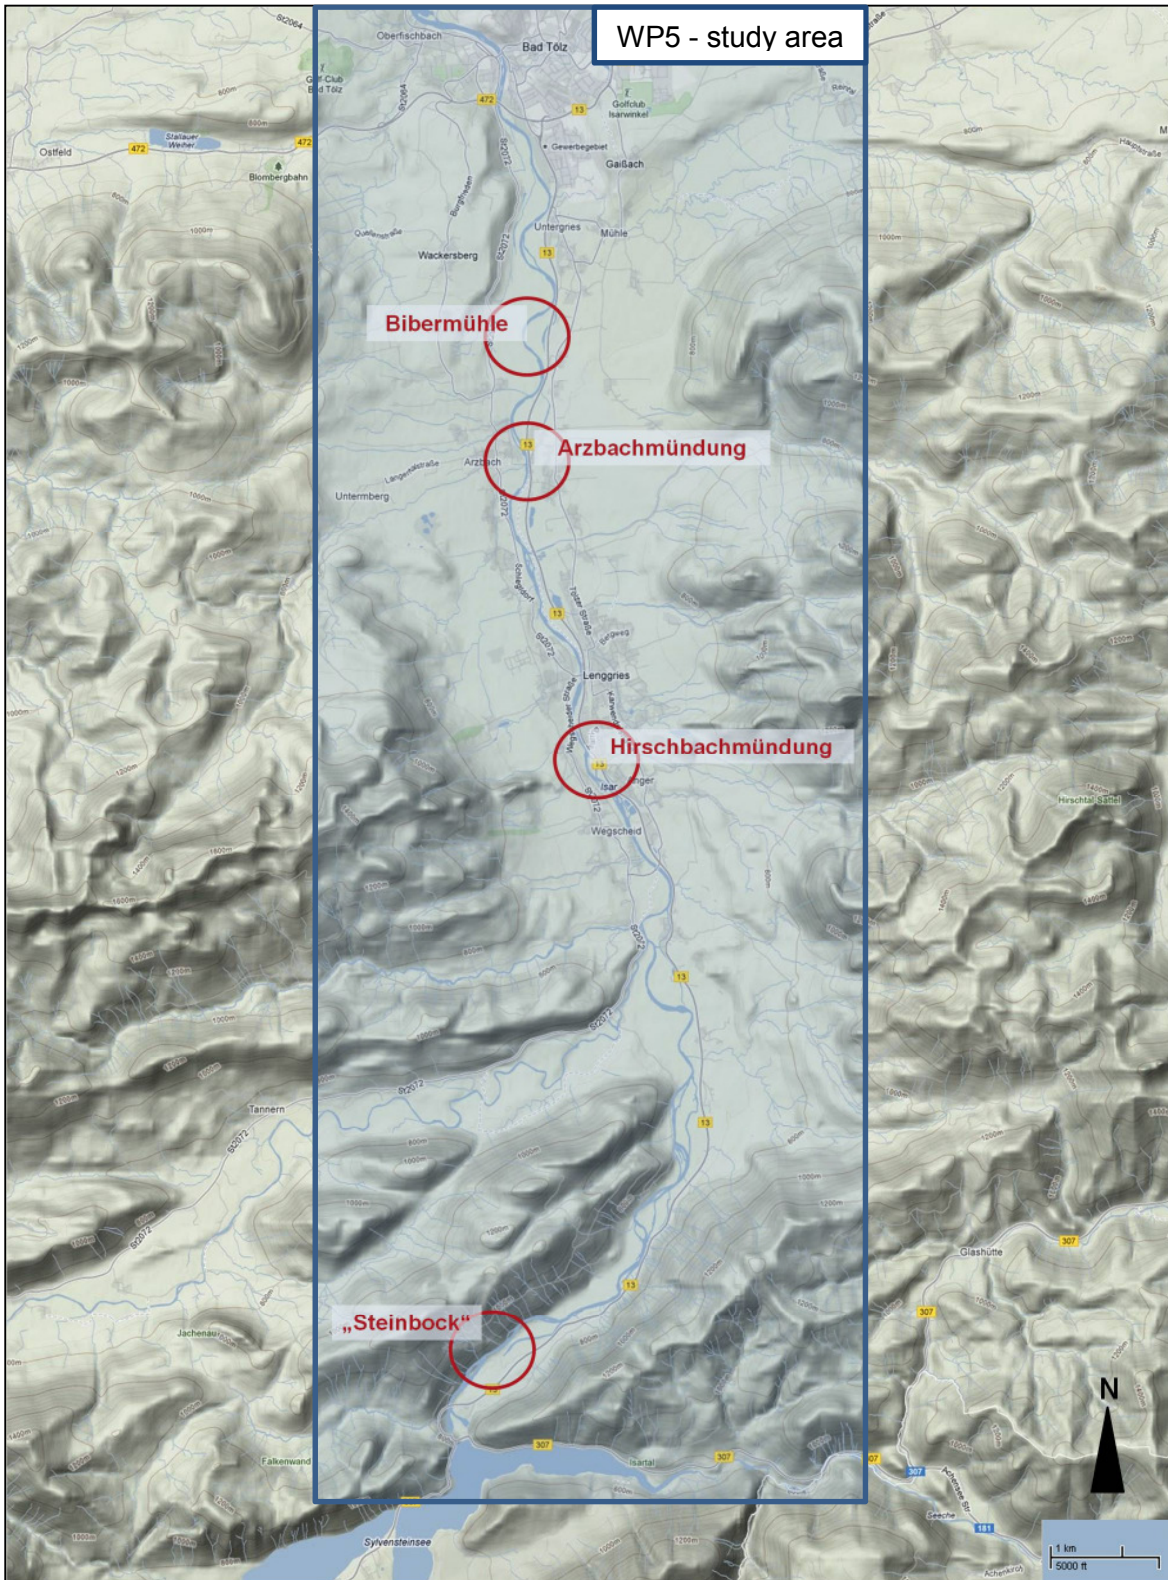
Figure 3: WP5-study area and monitoring stations along the river Isar (map based on Google Maps)
